NAME	DATE	mnegron	9/7/2007	CHECKED		ENG APPR		MGR APPR		TITLE V-800 Gallon Tank	SIZE A	MATERIAL: Error: No reference	REV
NAME	DATE													
mnegron	9/7/2007													
CHECKED														
ENG APPR														
MGR APPR														
UNLESS OTHERWISE SPECIFIED DIMENSIONS ARE IN INCHES ANGLES ±0.5° 2 PL ±0.125" 3 PL ±0.060"			FILE NAME: V-800 Vertical.dft											
PART#: 900800		WEIGHT: Error: No reference		SHEET 1 OF 1

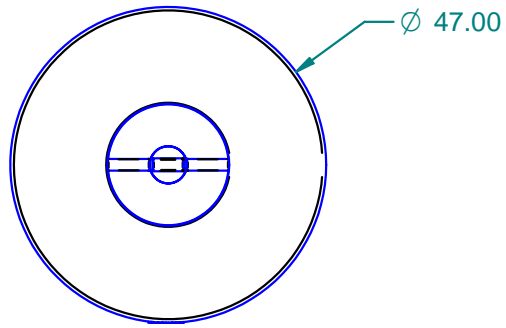
Top View

TANK IS CALIBRATED
IN 50 GAL INCREMENTS

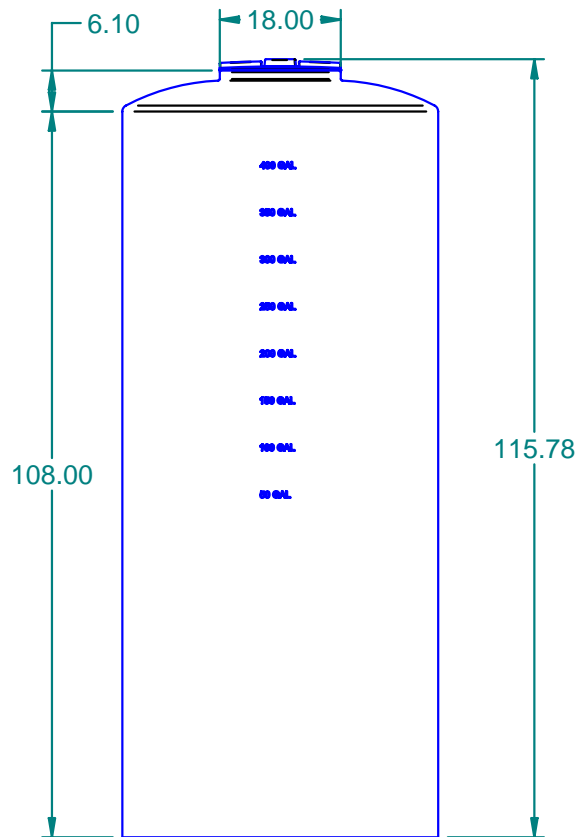
Side View

wall thickness: 0.350"
